**ATSB TRANSPORT SAFETY REPORT**  
Aviation Occurrence Investigation  
AO-2009-065  
Final

**Unreliable airspeed indication**  
**710 km south of Guam**  
**28 October 2009**  
**VH-EBA**  
**Airbus A330-202**

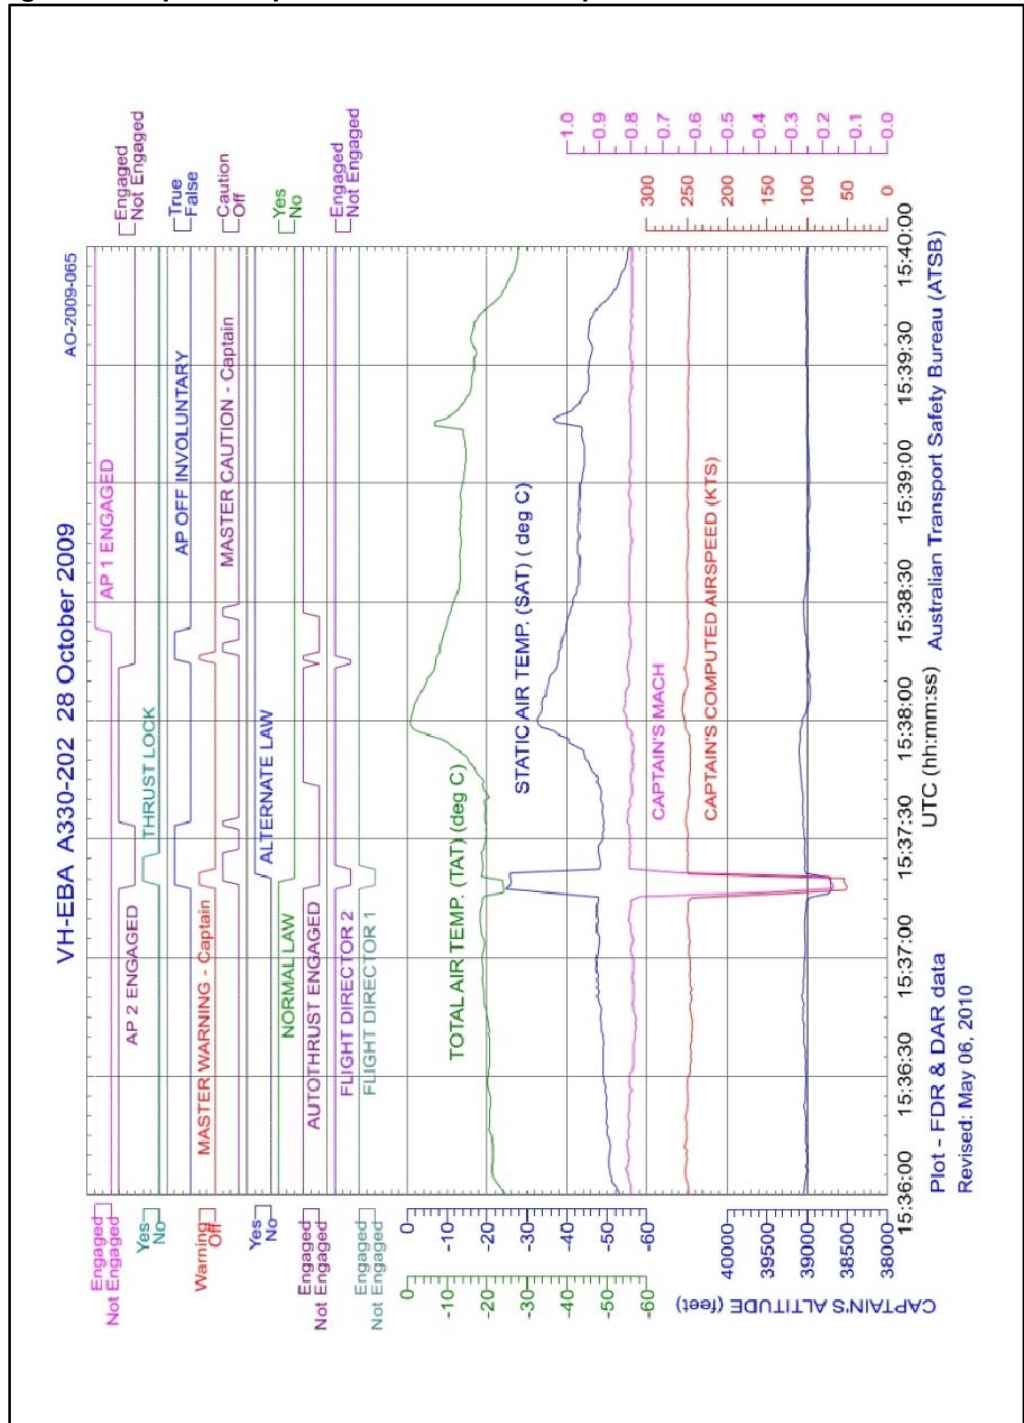
Figure 3: Graphical representation of relevant parameters

The recorders only sampled airspeed information from ADIRU 1, with values sampled four times per second. The data showed that, at 1537:17, the captain's computed airspeed started to rapidly drop. It reached a level of about 50 kts (Mach 0.17) for 4 seconds, and then returned to its previous level of about 250 kts (Mach 0.80) at 1537:22. No other anomalies were noted in the captain's airspeed data.

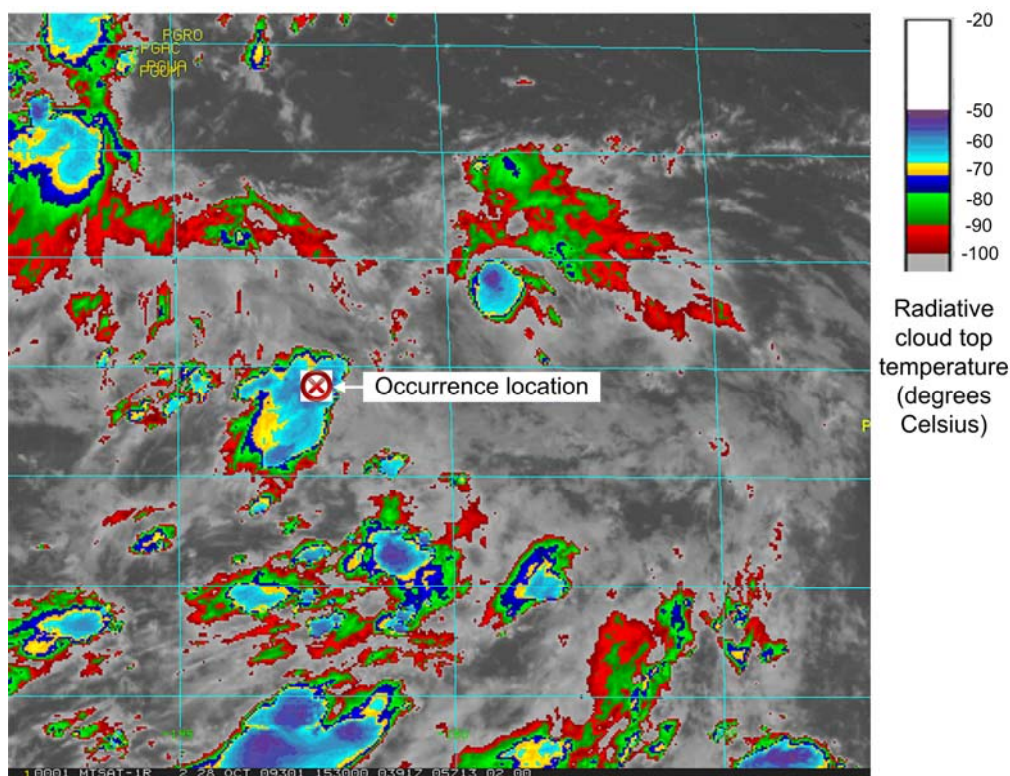
**Figure 4: Satellite image at 1530 on 28 October 2009**

The forecasted weather conditions for the flight included isolated, embedded cumulonimbus clouds in the tropical regions, up to FL 540. An image taken at 1530 on 28 October 2009 by the Japanese Meteorological Agency's multi-functional transport satellite (MTSAT) is shown in Figure 4. The aircraft's position at 1537 is shown by the red cross.

As indicated in the image (and a subsequent image taken at 1557), the aircraft was located within or under a large defined cluster of cumulonimbus clouds at the time

of the event. The radiative cloud top temperature<sup>17</sup> at 1530 was -71.6 °C, which corresponded to cloud tops of over 47,000 ft.

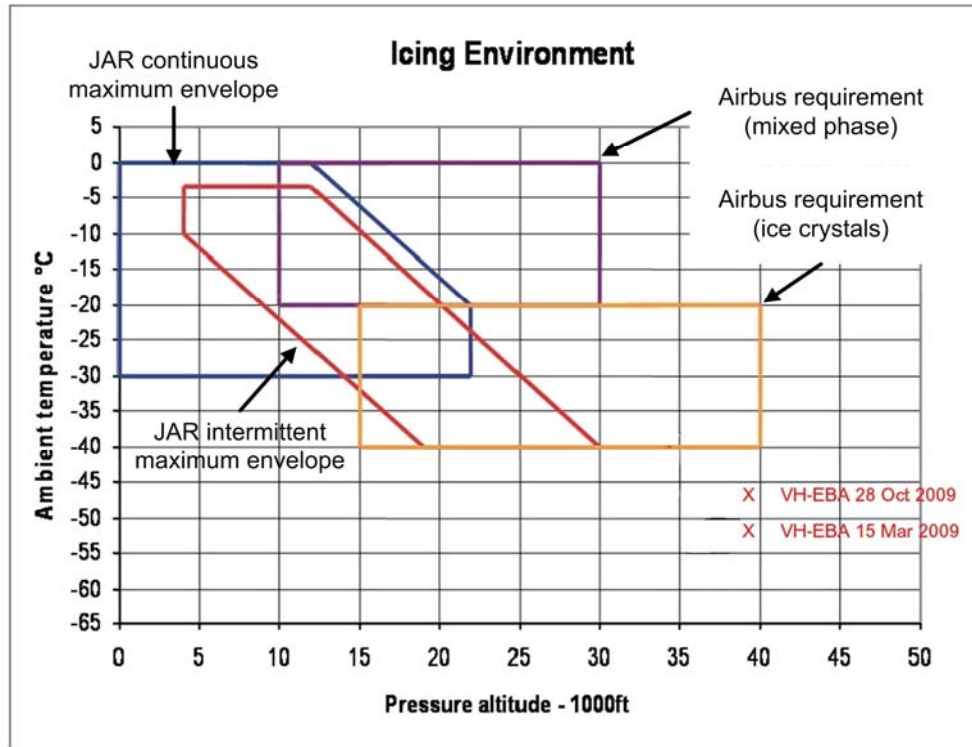
**Figure 5: Icing envelopes**

The JAR and the aircraft manufacturer's icing envelopes are plotted on Figure 5. In Appendix 4 of its second Interim Factual report on the AF447 accident, the BEA plotted the environmental conditions associated with 13 unreliable airspeed events for which detailed information was available. All of the events were outside the JAR envelopes. In addition, 12 events were outside the manufacturer's envelopes, with the other being just inside the lower temperature boundary for ice crystals. Figure 5 shows that the EBA occurrence on 28 October 2009 also occurred in conditions outside the JAR and manufacturer's envelopes. Based on the crew report of the SAT at the time, the 15 March 2009 event also occurred in conditions outside the envelopes.

In fact, the certification criteria are not representative of the conditions that are really encountered at high altitude, for example with regard to temperatures. In addition, it appears that some elements, such as the size of the ice crystals within cloud masses, are little known and that it is consequently difficult to evaluate the effect that they may have on some equipment, in particular the Pitot probes. In this context, the tests aimed at the validation of this equipment do not appear to be well-adapted to flights at high altitude.
